OIL & NATURAL GAS CORPORATION (WOU) KARMACHARI SANGHTANA

REF. : ONGC/KS/ 615/2019

Subject : Immediate replacement of Old Electrical Panels to avoid recurrence of electrical accidents in the Uran Plant.

Pics. Of Electrical Accident happened on 13/05/2019 at LPG- I Substation.

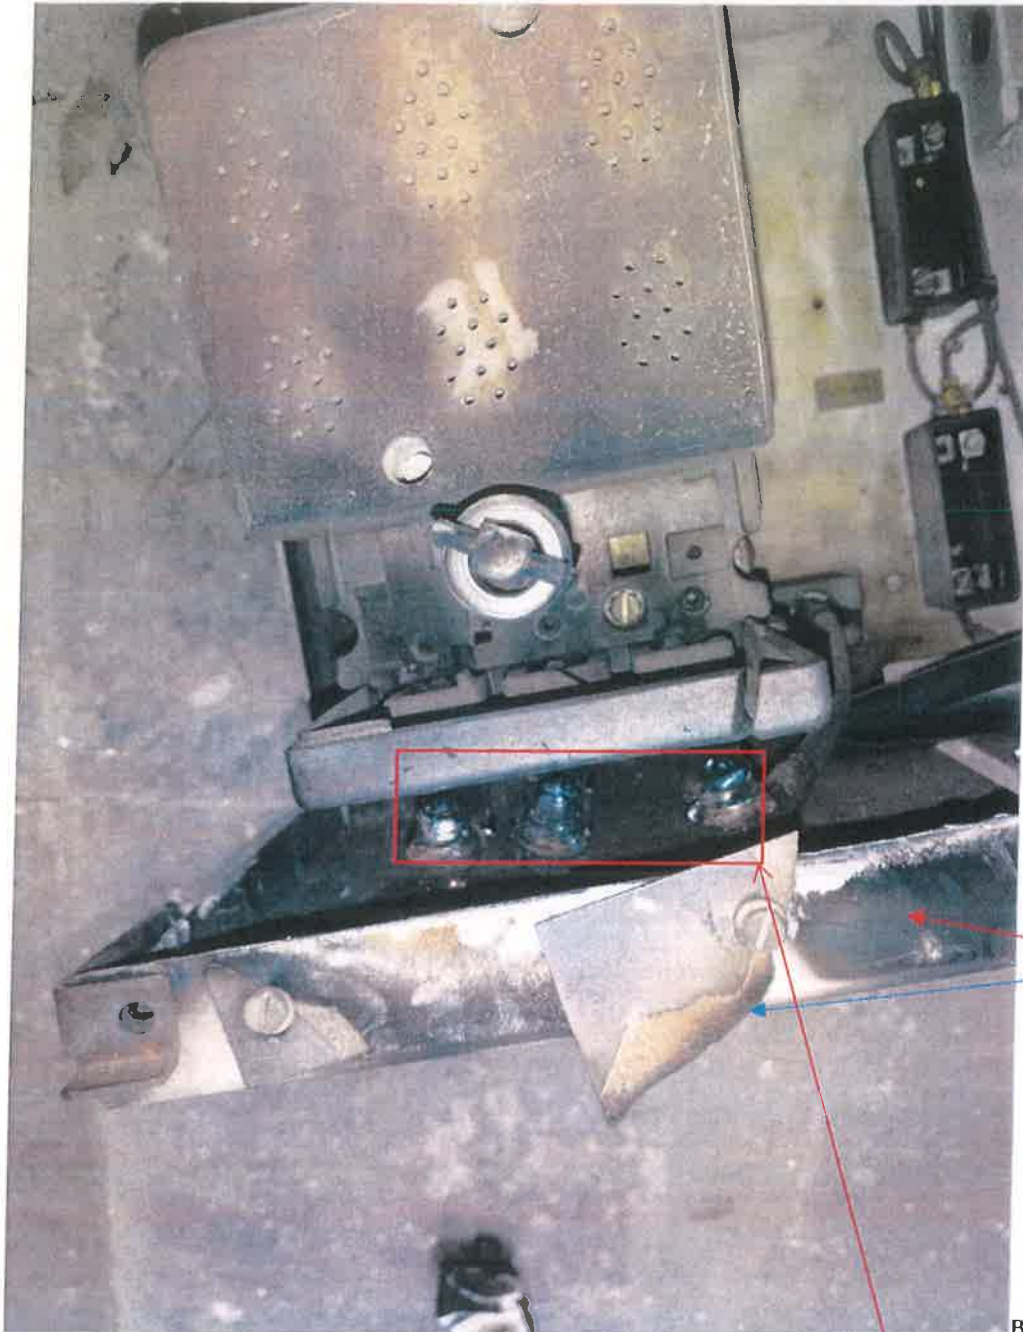
(1)

The accident took place at LPG-I Substation. After completion of repair of motor P-320 A at LPG - I field area to put ON the power Shri Hemant Thali released the lock out, he put on the HRC (High Rupturing Capacity) fuses in the Electrical Panel. At the time of putting HRC fuses Electrical spark took place & fumes came on his face, causing serious burns on his face & hand. Normally HRC (High Rupturing Capacity) fuses never breaks; but HRC fuse totally damaged in to two pieces. This was second such incident within six months.

Blackened & Broken Part

Melted Terminals of Electrical Module

Your esteemed authority is requested to kindly direct the concerned department to initiate procurement of new panels more technically equipped and with more safe handling systems for immediate replacement of the existing Electrical Panels to avoid further fatal accidents in Uran Plant.

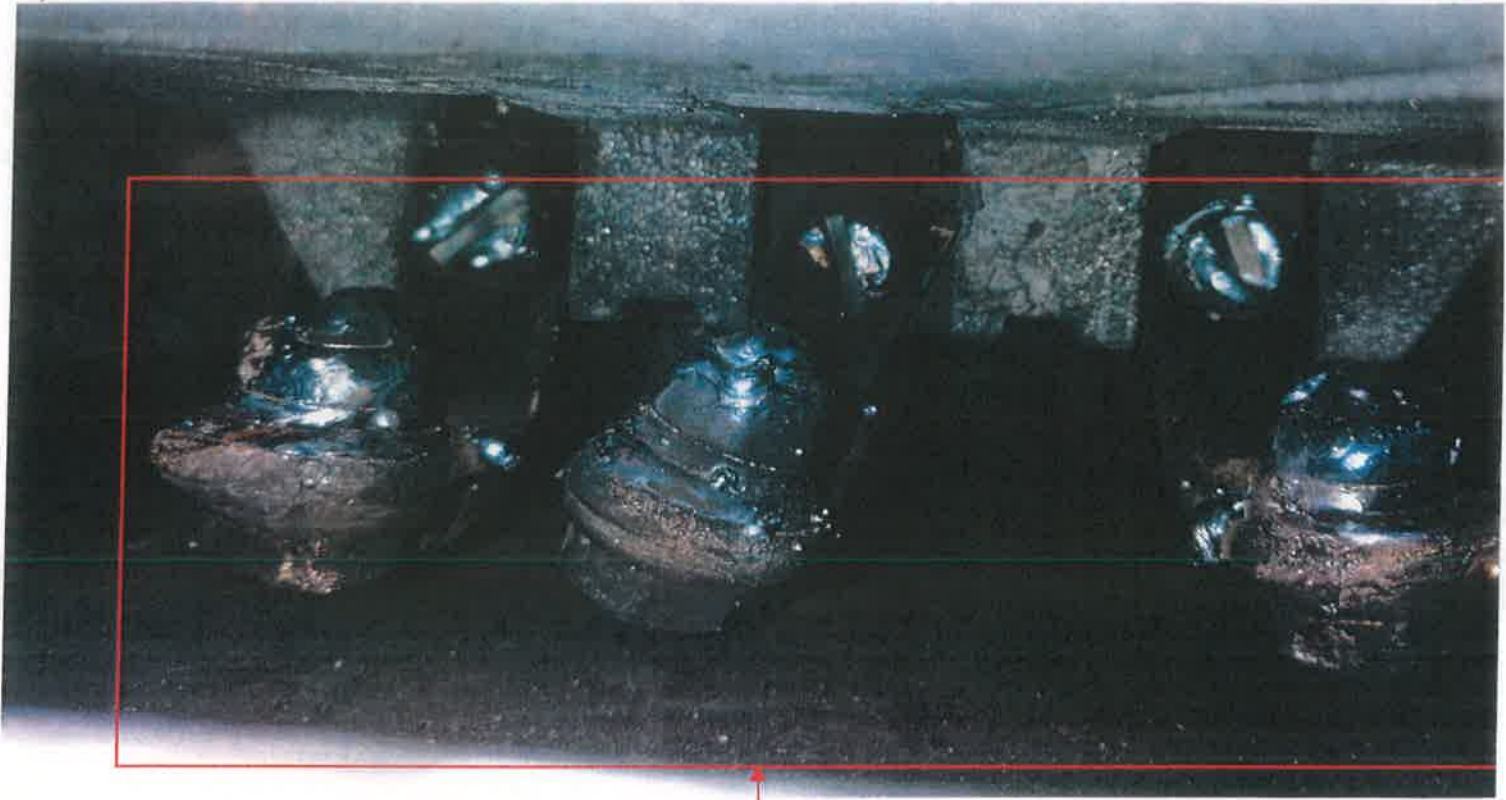
(2)

Melted Terminals of Electrical Module

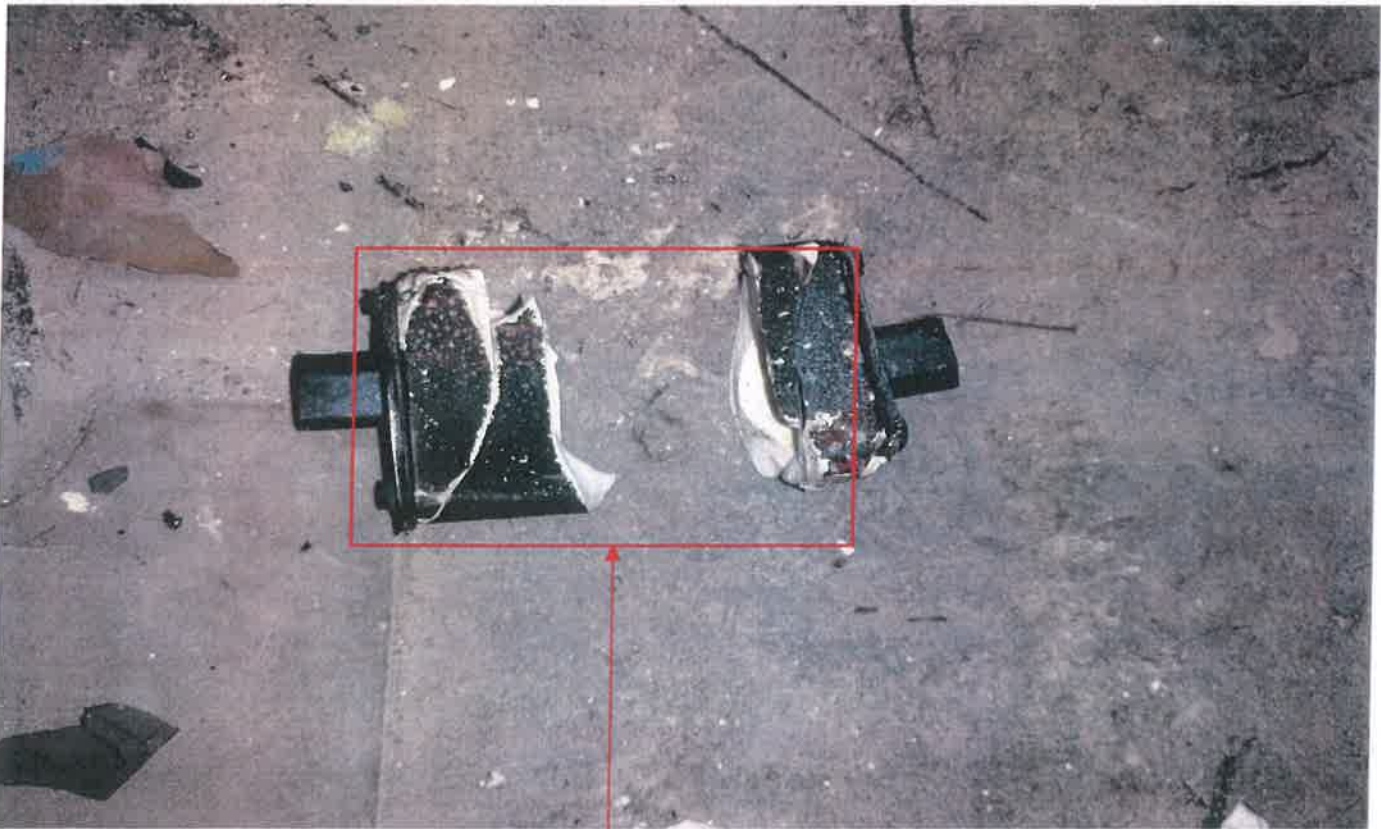
(3)

Broken HRC (High Rupturing Capacity) Fuse

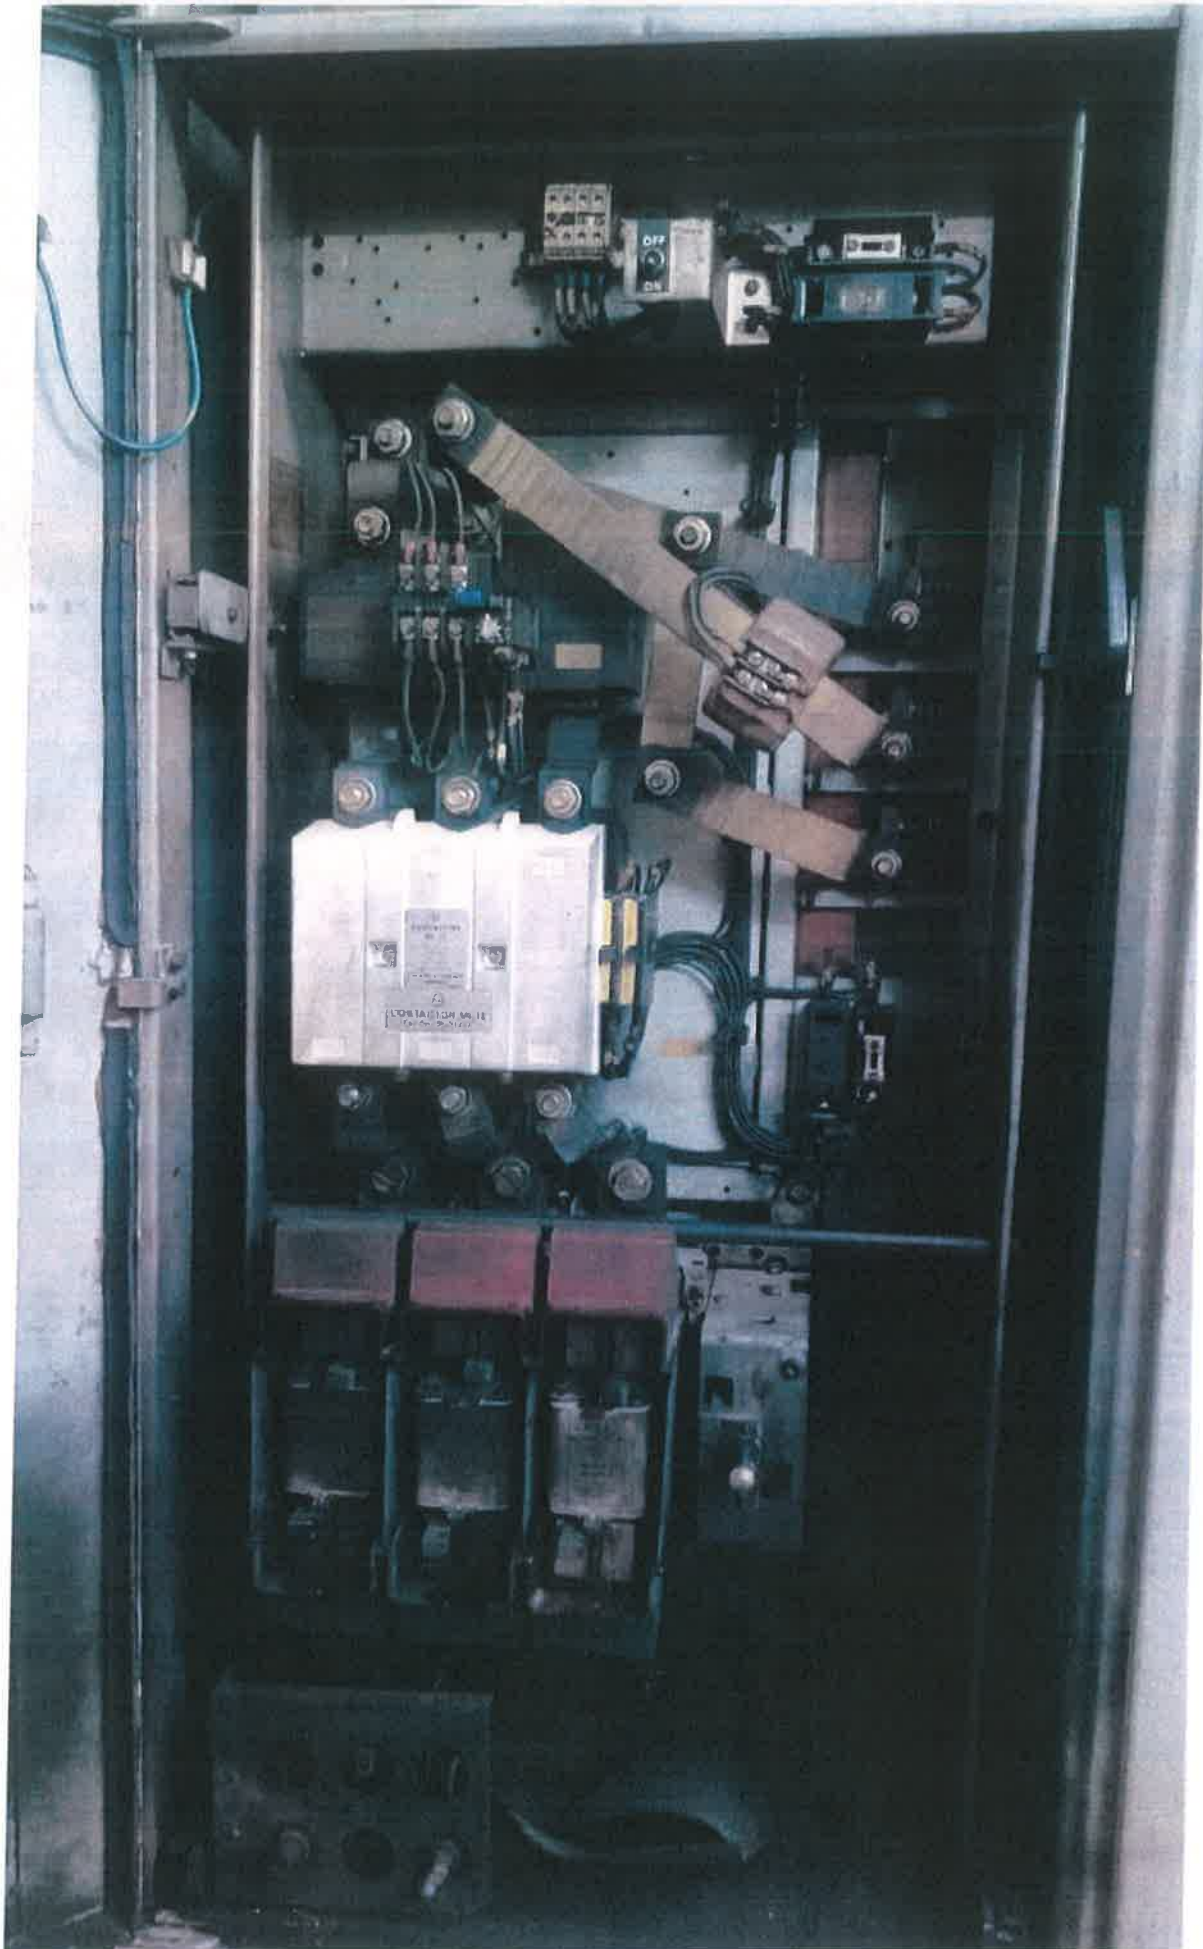
(1)

The first incident happened on 17 December 2018 at 18:00 Hrs. in Utility Substation MCC No.390. While starting IG compressor there was flashover in its Electrical Module. The module was badly carbonized due to flashover.

On 17/12/2018 ; 18:00 Hrs at Utility Substation, Flashover in Electrical Module of IG Compressor (MCC No.390)

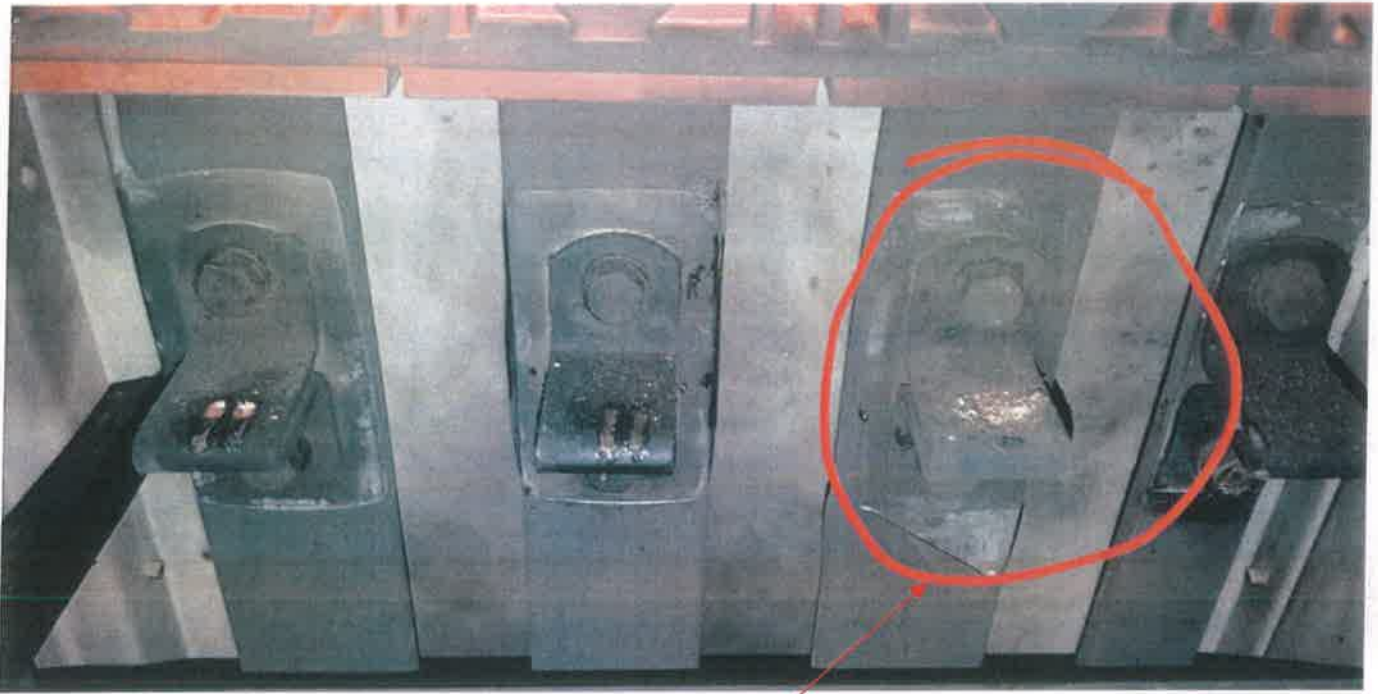
(2)

Melted & Burned Electrical Male Contact

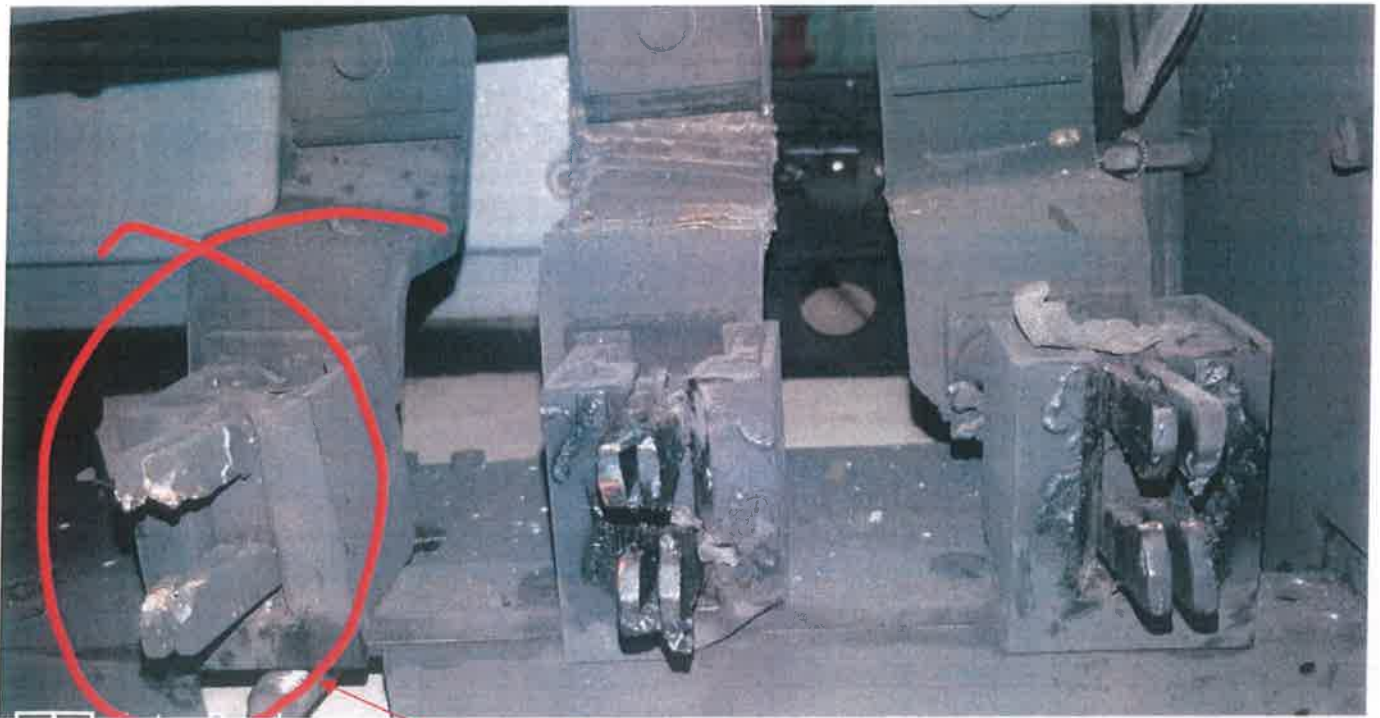
(3)

Melted & Burned Electrical Female Contacts

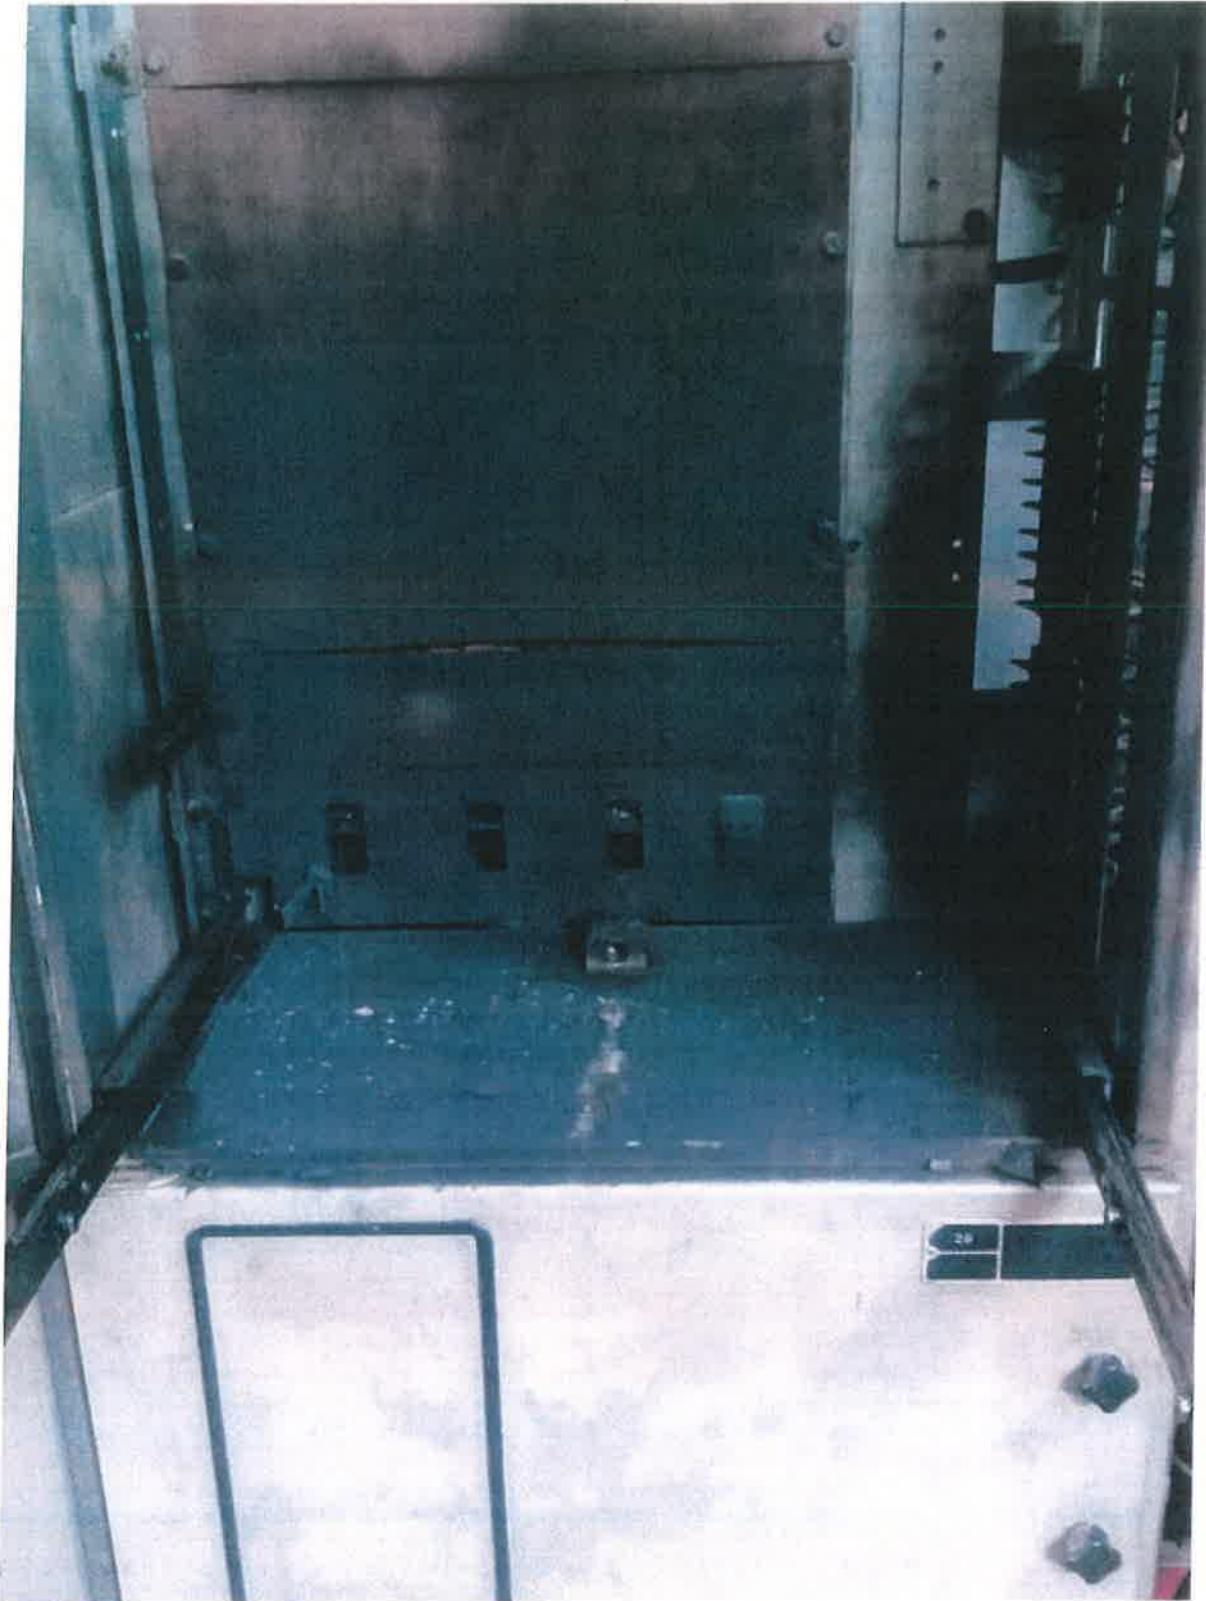
(4)

Blackened Electrical Module Compartment due to Flashover
