OIL & NATURAL GAS CORPORATION (WOU) KARMACHARI SANGHTANA

REF. : ONGC/KS/ 615/2019

Subject : Immediate replacement of Old Electrical Panels to avoid recurrence of electrical accidents in the Uran Plant.

Pics. Of Electrical Accident happened on 13/05/2019 at LPG- I Substation.

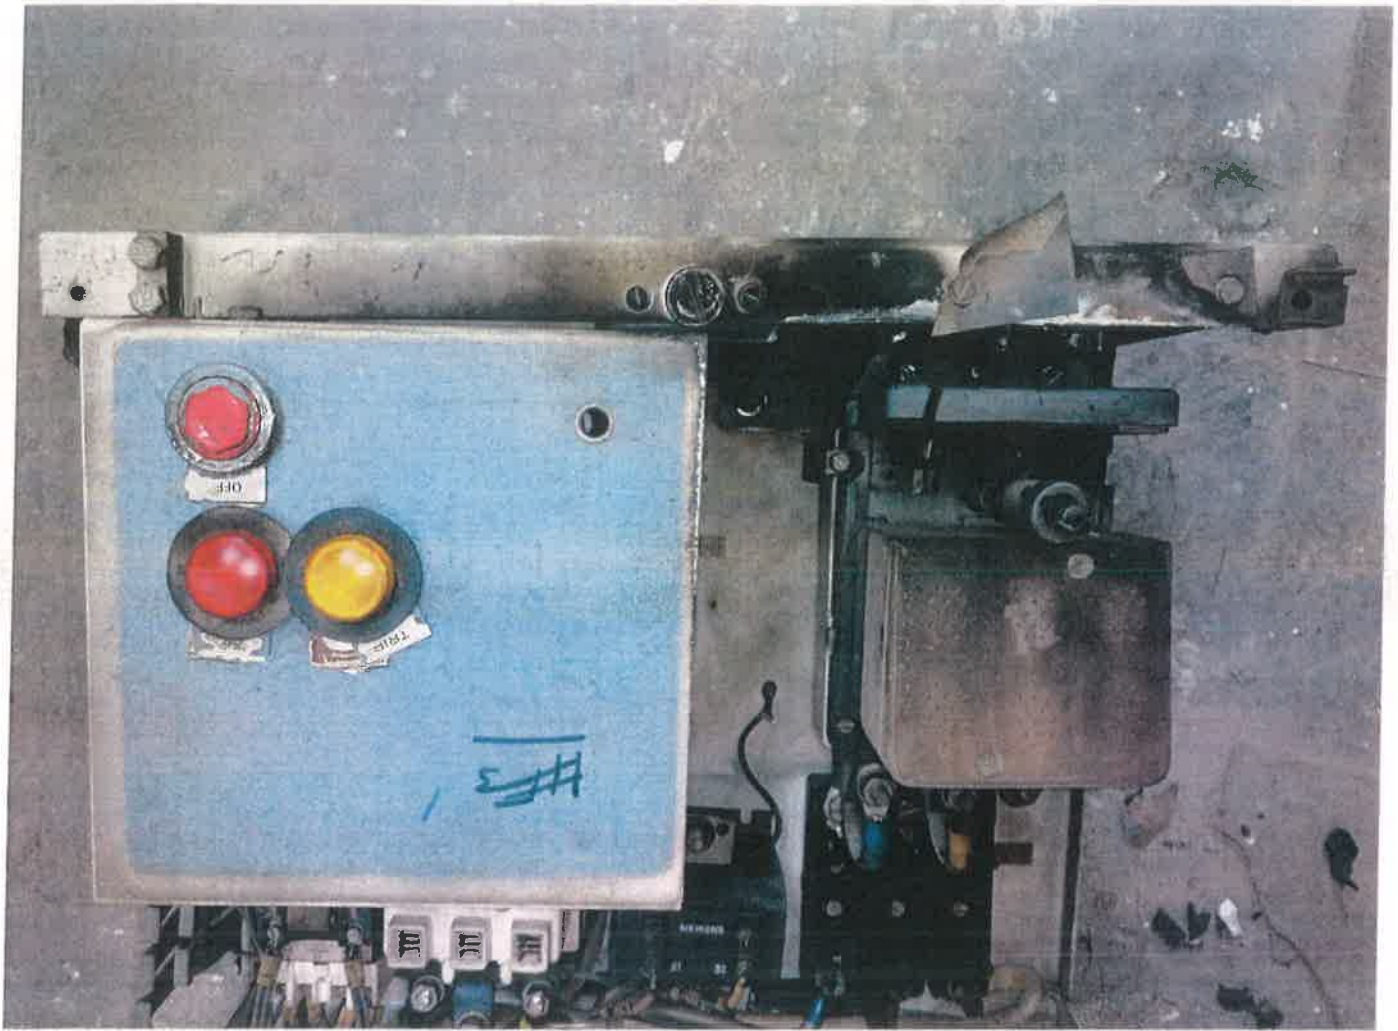
(1)

The first incident happened on 17 December 2018 at 18:00 Hrs. in Utility Substation MCC No.390. While starting IG compressor there was flashover in its Electrical Module. The module was badly carbonized due to flashover.

On 17/12/2018 ; 18:00 Hrs at Utility Substation, Flashover in Electrical Module of IG Compressor (MCC No.390)

Your esteemed authority is requested to kindly direct the concerned department to initiate procurement of new panels more technically equipped and with more safe handling systems for immediate replacement of the existing Electrical Panels to avoid further fatal accidents in Uran Plant.
